# Application Note

## Shoulder/Edge-of-Pavement(EOP) Condition Assessment

### #AN-Pavements-001

July 26, 2001

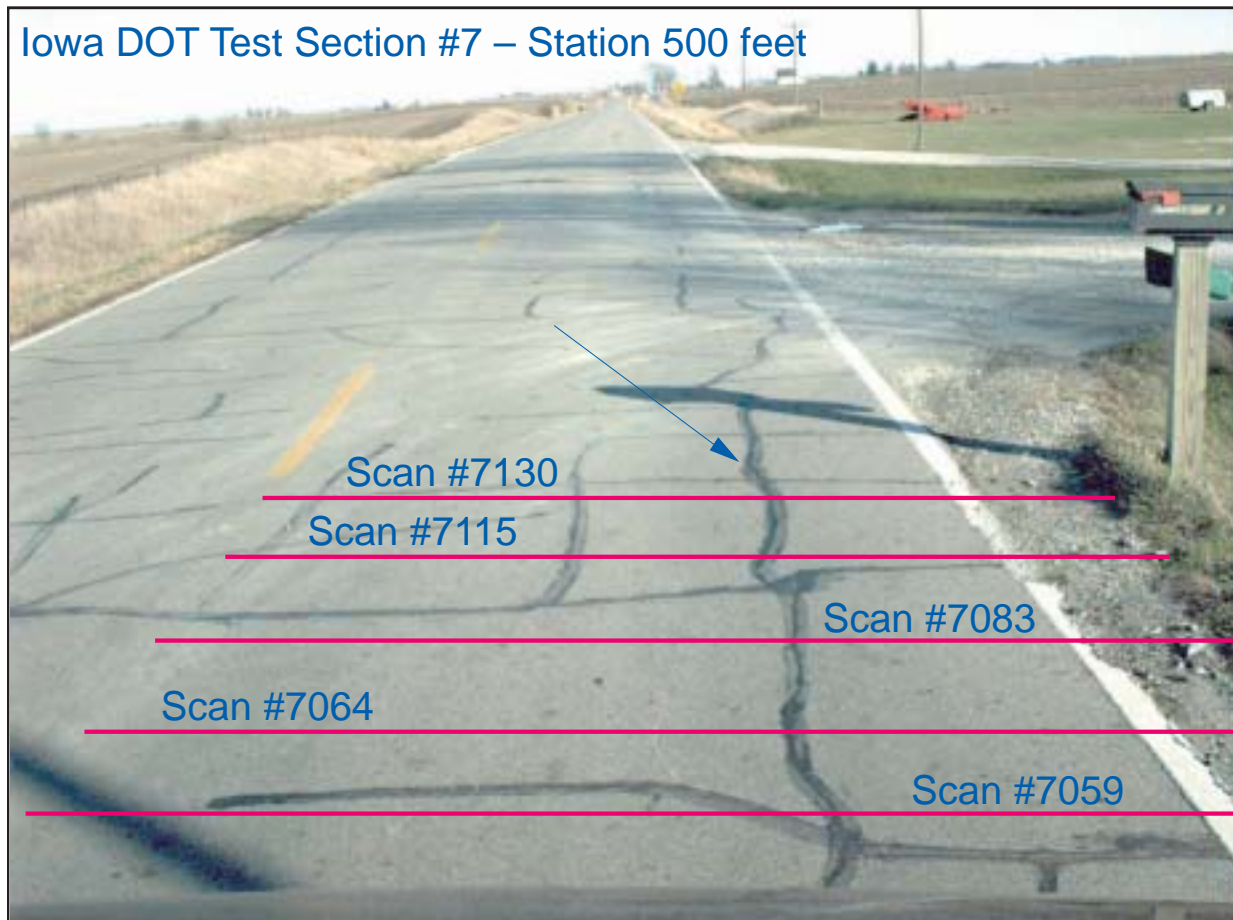
**Background.** A PSI PPS-2000 Pavement Profile scanner (USACE-WES s/n 2) was operated on Iowa DOT test roads in November 2000 on a Mandli Digilog van. The following Digilog image of section 7, station 500 feet shows a cracked and sealed AC pavement with a stretch of about 5 feet where the shoulder was broken away under the fog line. The profile and signal strength for the five scans taken nominally at the positions shown by the transverse red lines has been plotted.

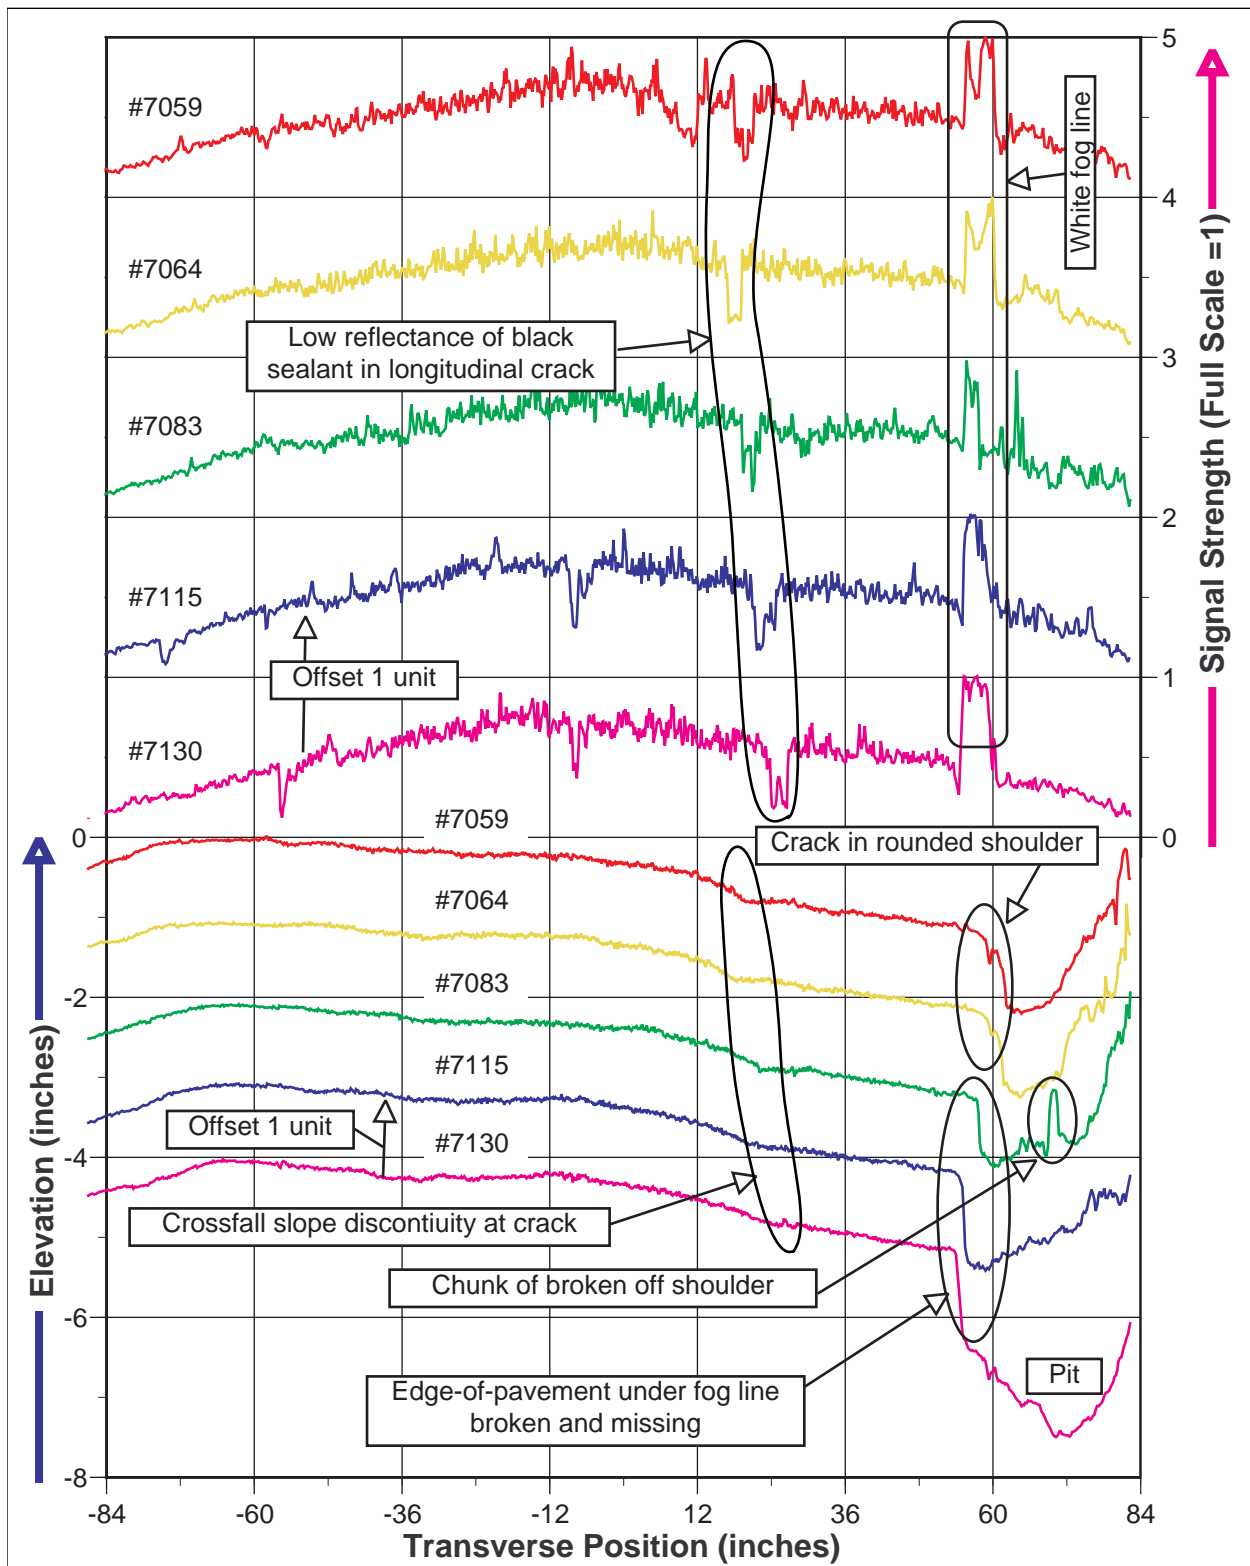
**Scan 7059.** In addition to the long sealed longitudinal crack (blue arrow), a transverse sealed crack is visible in the normalized signal strength curve as a downward spike. Crossfall slope discontinuity present at the longitudinal crack. The fog line results in a clear plateau suitable for locating to profile transversely.

**Scan 7064.** Shoulder/EOP is (7059 also) is gently rounded. Crack at EOP is visible in profile.

**Scan 7083.** Chunk of broken shoulder presents a blip in profile in the gravel.

**Scan 7115.** The abrupt drop off of the broken shoulder is noticeably different (also in 7083 and 7130) from the normal rounded shoulder in 7059 and 7065. The reduced signal from three sealed cracks is apparent.

**Scan 7130.** A pit which would hold a puddle of water from rain is shadowed in the image but clear in the profile. The outcome of repainting the fogline after the shoulder failed is uniform fogline intensity plateaus in all the scans, even where the profile reveals missing shoulder under the fog line.

Signal Strength above and profile below from 5 scans of Run 11 on November 4, 2000 on Iowa DOT section 7 at station 500 feet. Successive scans are offset vertically by 1 for clarity.
